B. Watershed Health and Aquatic Habitats

1. Existing Condition

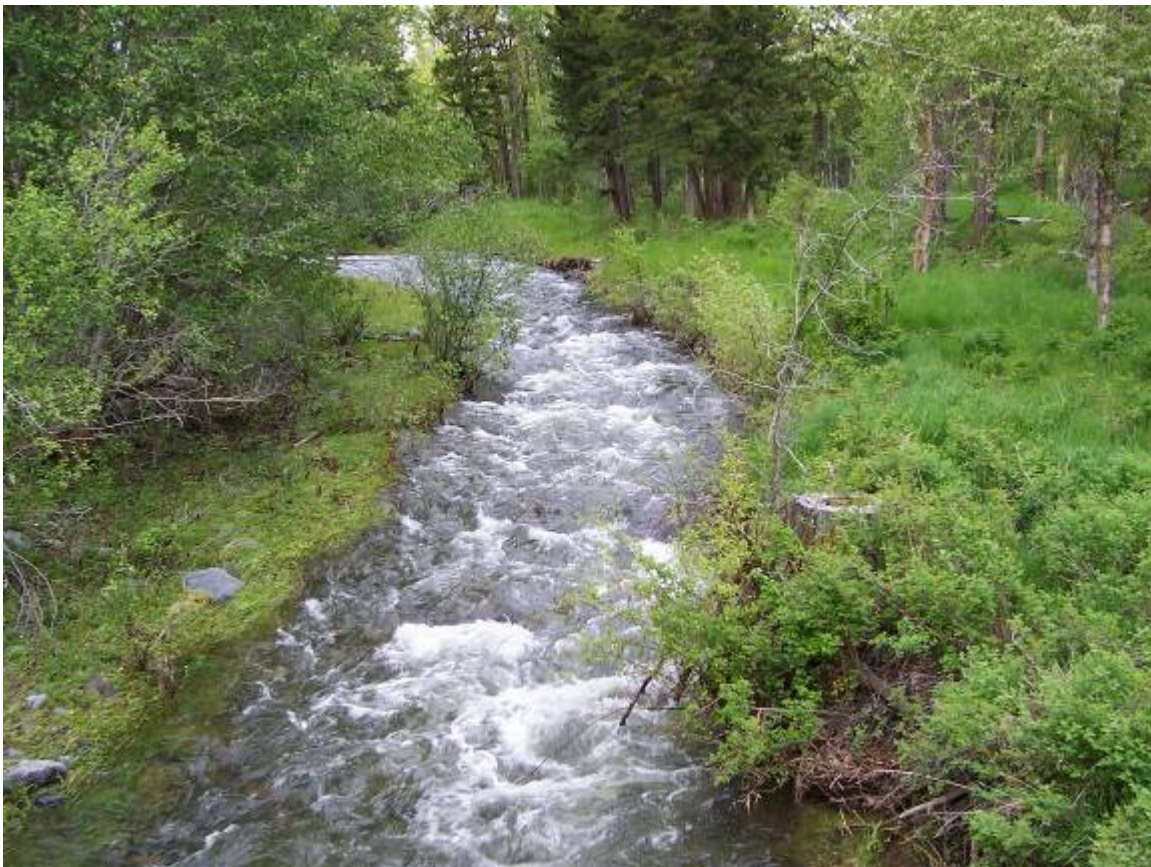
Photo: Lower Cottonwood Creek at WRC site C4 during spring runoff June 2005.

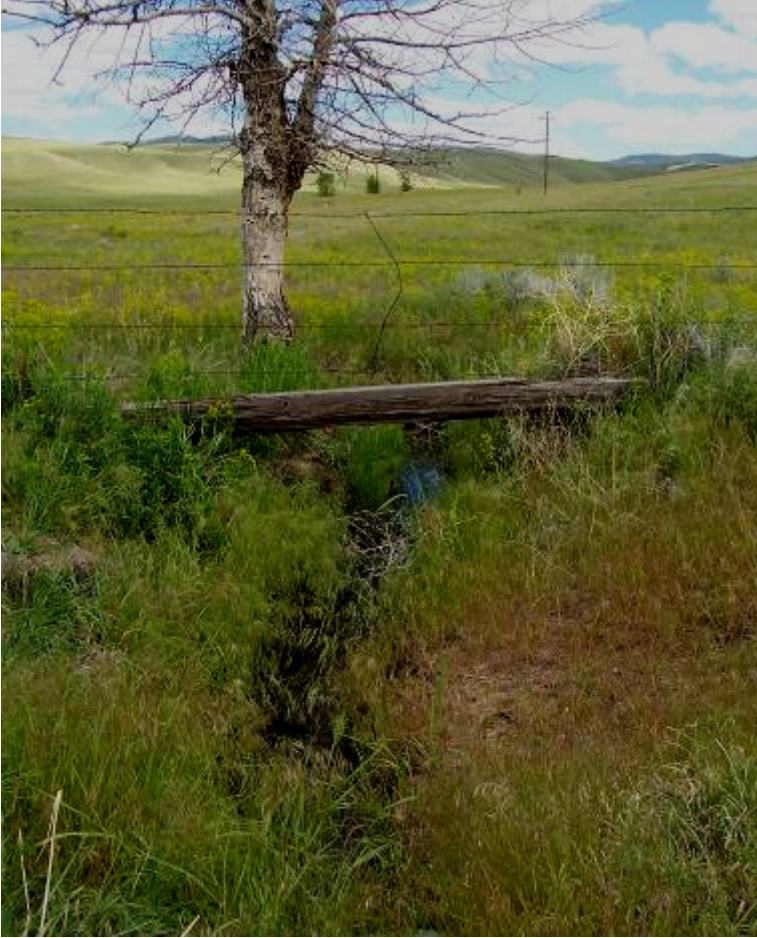
Photo: Perkins Gulch at Eastside Road during an infrequent connection to the Clark Fork River, spring runoff 2005.

Most streams in the project area are considered losing streams in the lower reaches. High infiltration rates on coarse sand, gravel and cobbles appears to be the limiting factors for why most streams do not reach the Clark Fork River. Expansive dry benches divide the streams in the landscape, and several miles of rangeland typically separate one stream from the next. The result of a spatially limited water supply is critical for how ecosystem and agricultural practices interface in the landscape. Notably, the streams act as linear oases that draw wildlife and cattle into the riparian areas for water. Pressure from excess riparian cattle watering and use is one of the key limiting factors leading to aquatic impairment in the streams.

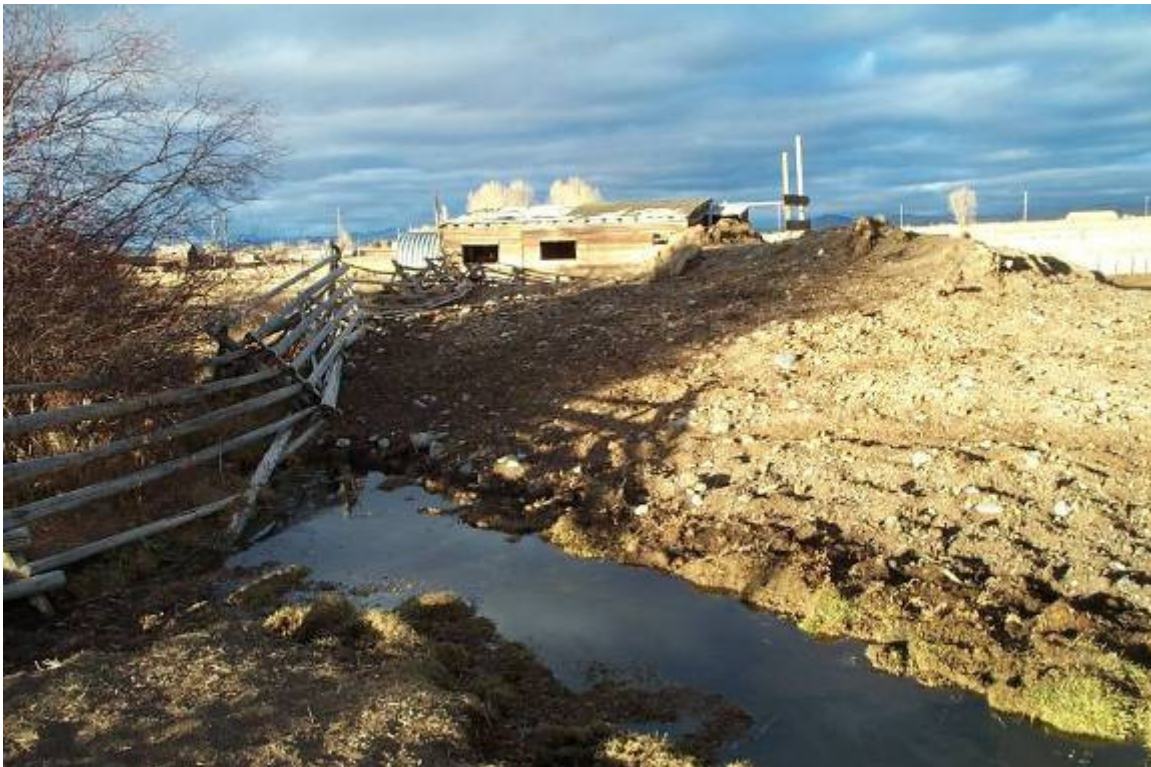
Photo: Nutrient management issue on private lands on Peterson Creek. This operation is planned to be modified in cooperation with the WRC.
